# MEASURING RECORD MAIN ENGINE

| Work | OVERHAULD | Kapal : | KM. KUTAI RAYA II |

# LAPORAN PEKERJAAN

## MAIN ENGINE

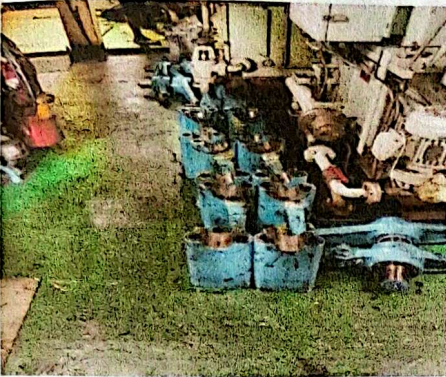
### 1 Roker Arm

1. Buka baut pengikat roker arm cyl 1 dan cyl 6
2. Bongkar-pasang pipa-pipa injektor cyl 1 dan cyl 6
3. Bongkar-pasang pipa pendingin injektor, pipa pelumasan - noken arm cyl 1 dan cyl 6
4. Bongkar pasang Roken arm cyl 1 dan cyl 6
5. Cabut pondasi noken arm, cabut Poshrood cyl 1 s/d cyl 6
6. Pipa pendingin cyl head 1 s/d cyl 6
7. Pipa pembuangan cyl1 s/d cyl 6

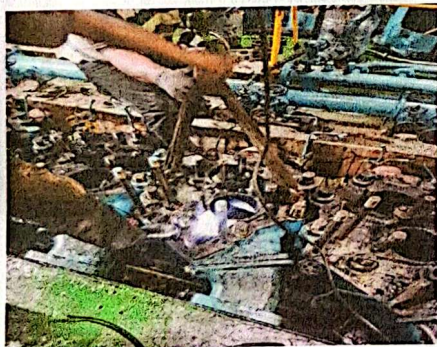
#### Cyl head

#### Proses Pengangkatan cyl head :

- a. Buka baut manifold buang & Isap cyl 1 s/d cyl 6
- b. Buka baut pipa starting valve cyl 1 s/d 6
- c. Buka baut pipa angin stanby cyl 1 s/d 6
- d. Buka baut pengikat cyl head cyl 1 s/d 6
- d. Cabut cyl head cyl 1 s/d cyl 6, Cleaning dan diadakan Penyekiran Valve isap ( 6 pcs ).
- e. Cleaning cyl head 1 s/d 6

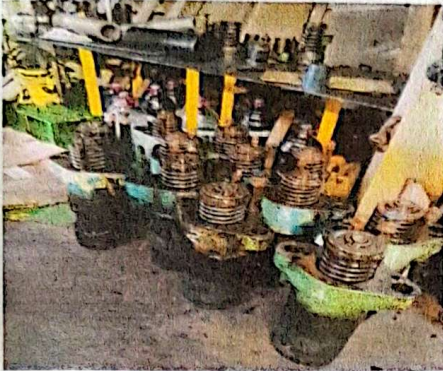
### 5 Housing Valve Inlet + Exhouse

- a. Valve Ex di lepas, di cleaning
- b. Cek kondisi Valve , setting dan Bushing kondisi baik
- c. Lepas Ring Valve di cleaning
- c. Diadakan Penyekiran:
  1. Setting dengan Housing ( kedudukannya ) cyl 1 s/d - cyl 6
  2. Valve dengan setting cyl 1 s/d cyl 6

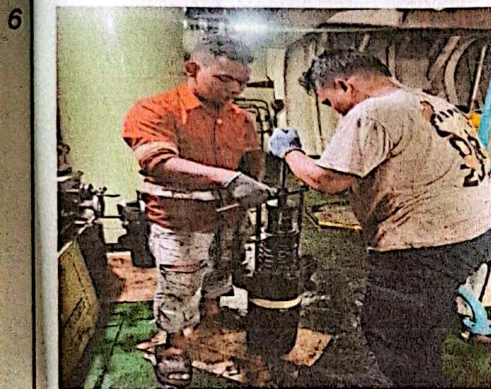
Proses pelepasan / perakitan valve inlet atau exhouse  
12 set ( valve inlet dan valve exhouse )

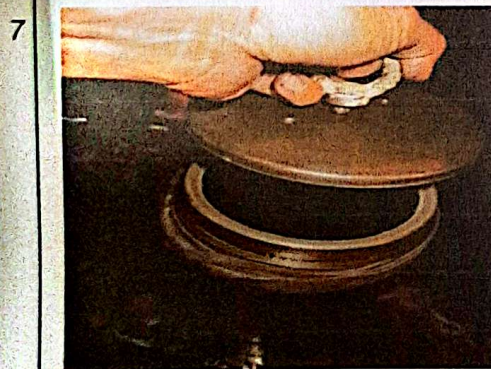
1. Proses Penyekiran Valve Exshos cyl 1 s/d 6
2. penyekiran valve intake cyl 1 s/d cyl 6

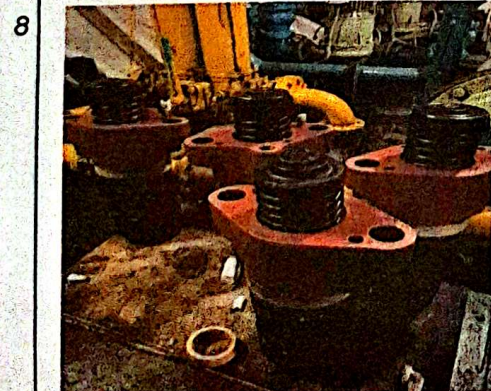
- a. setelah penyekiran set kembali
- b. Housing valve Inlet dan Exhouse di cat ulang

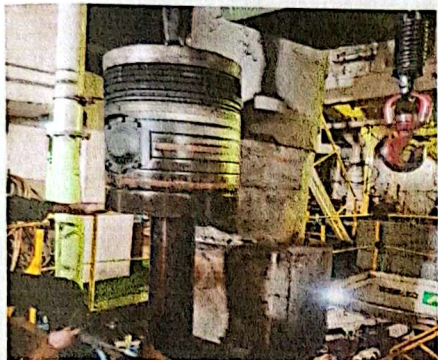
Piston

Proses pencabutan piston :

1. Lepas baut pengikat crankpin bearing cyl 1 s/d cyl 6
2. Cabut piston cyl 1 s/d 6
3. Lepas ring piston cyl 1 s/d cyl 6
4. Cleaning piston, grove dan diadakan pengukuran.

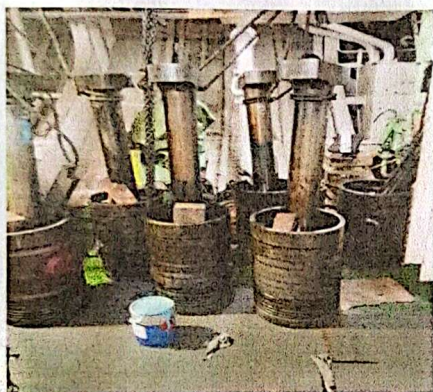
- a. Piston di pindahkan k e lantai belakang untuk proses pelepasan piston sama conrood cyl 1 s/d cyl 6
- b. cek kondisi bushpin piston & conrood
- c. Repair di bengkel Mahkota surabaya

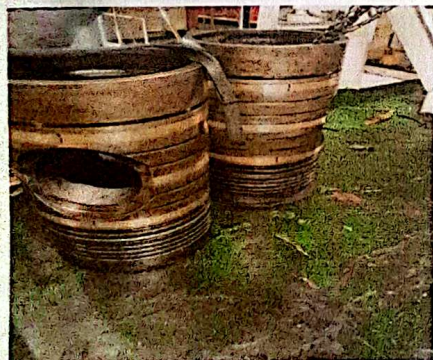
11

- a. Penggantian sabuk piston skirt baru 6 cyl ( 6 pcs ) di bengkel Mahkota surabaya ( bahan brons )
- b. Piston skirt sama piston crown di lepas

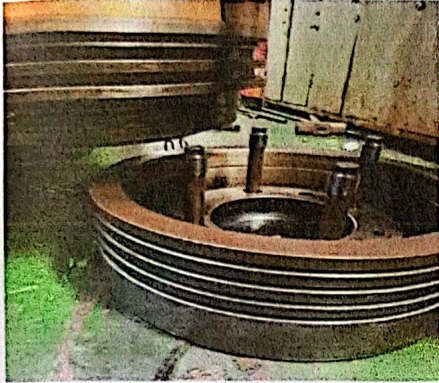
Piston Crown

Proses pelepasan atau perakitan piston crown dan skirt

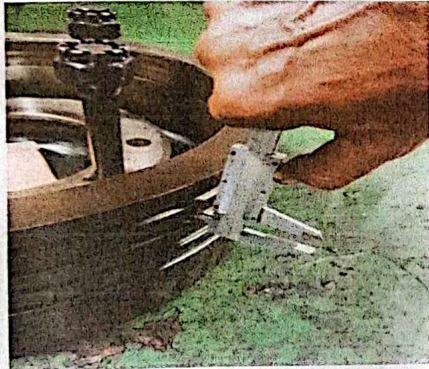
14

Pengukuran groove ( rumah ring piston )

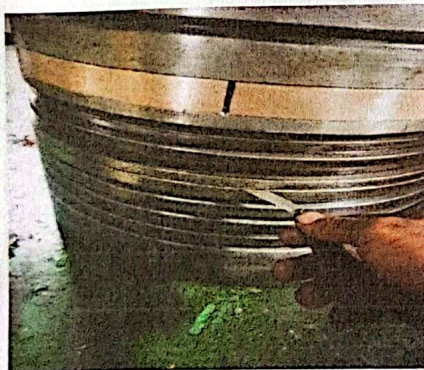
15

- setelah pemasangan piston crown - piston skirt
- diadakan pengambilan clarence antara piston crown & piston skirt menggunakan fuller.
- Clarence antara : 0,25 - 0,30 mm

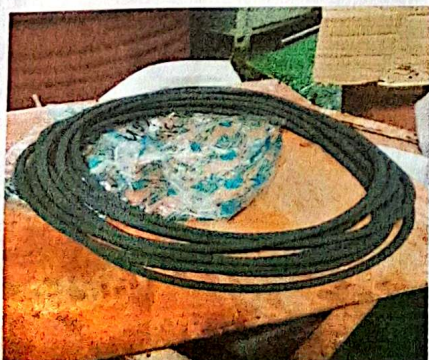
Oring Crown

Penggantian oring Piston crown baru ( dr jakarta )  
terpasang di cyl 1 dan 2  
Jenis Oring ( viton )

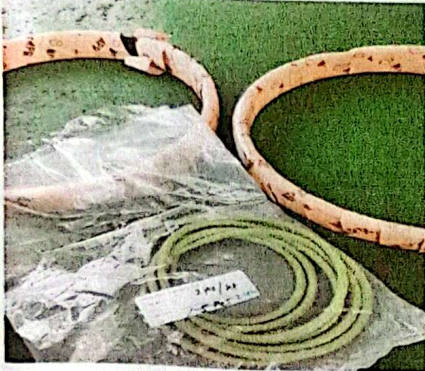
Oring crown

- Oring baru Crown ( viton ) dr surabaya 4 pcs terpasang di cyl no 3,4,5,6
- Ring piston NPR dr surabaya terpasang di cyl 1

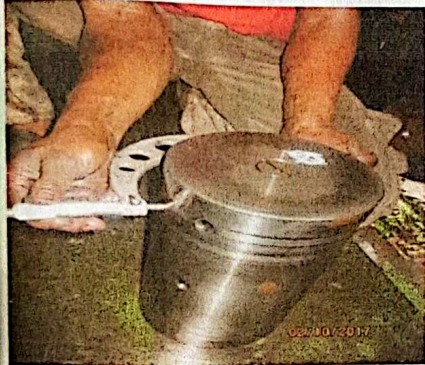
Pin Piston

- Pengukuran  $\phi$  Pin piston
- Menggunakan micrometer outside

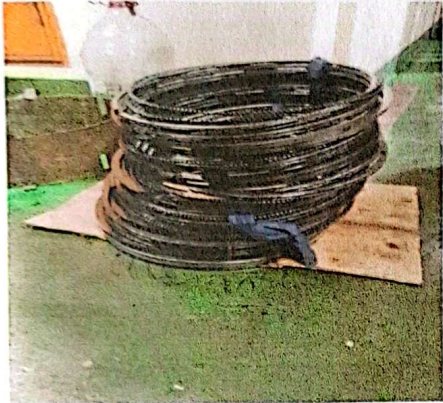
21

- a. Ring Piston lama
- b. kondisi gap sudah besar : 7.60 mm
- c. di adakan penggantian ring piston baru

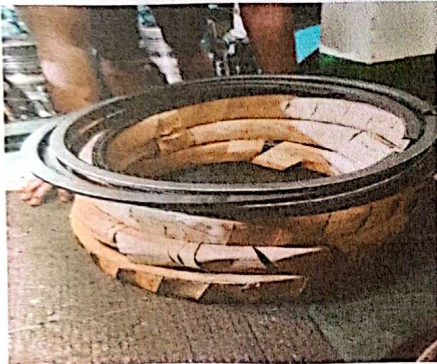
22

- a. Ring piston baru NPR 4 set ( jakarta )  
peamasangan di cyl 3,4,5,6
- b. Ring piston baru NPR 2 set ( surabaya )  
Pemasangan di cyl 1
- c. Ring piston baru spert Kapal 1 set ( 3 pcs )  
pemasangan di cyl 2,  
ring oli screver dr spert-part surabaya

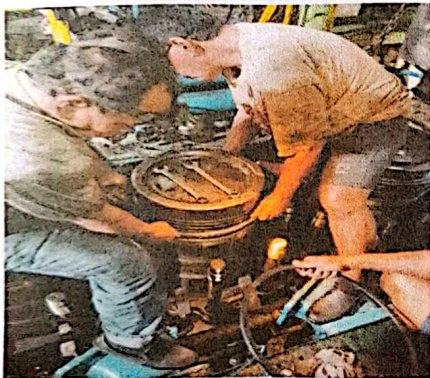
23

Pemasangan Ring piston baru 6 cyl  
Cyl 1 s/d cyl 6

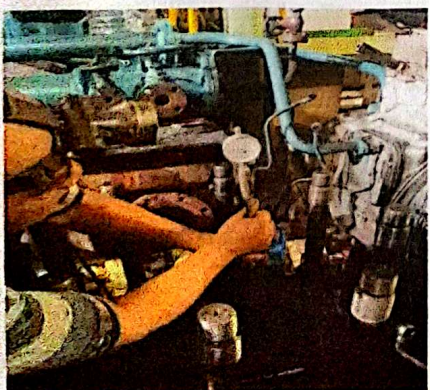
Liner

Pengambilan data ukur  $\varnothing$  liner dr cyl 1 s/d cyl 6

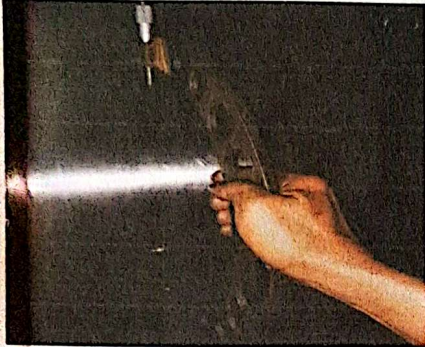
Pengukuran Crankpin Jurnal

- Pengambilan data / pengukuran  $\phi$  Crankpin jurnal
- Menggunakan micrometer out side

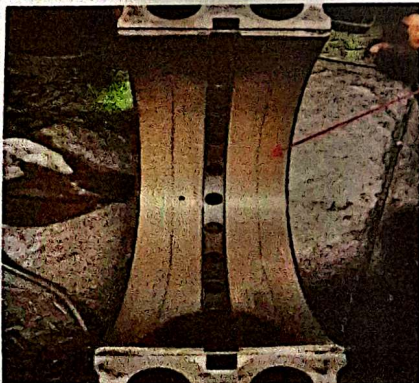
28

- Main Bearing
- Pengambilan data menggunakan kawat locis ( lodrat )
  - hasil locis : samping 0,25 mm  
tengah 0,28 mm  
samping 0,26 mm
  - metal lama pasang kembali

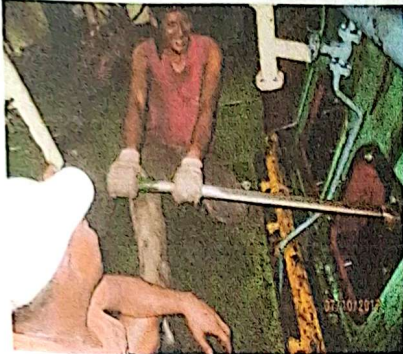
Pengikatan nut conencting rood menggunakan kunci moment dengan ikatan 700 kg/cm

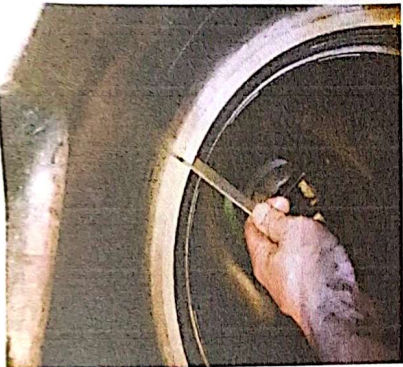
Gap Ring Piston

Pengambilan data Gap ring piston lama  
Gap ring piston lama : terutama compresi 7,60 mm

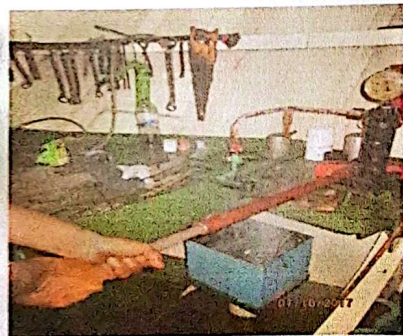
Prest- test Injektor lama dg tekanan 280 kg/cm
